Early Loading to Deploy Overlay Joints: Does It Work?

Principal Investigator: Mike Wallace, MnDOT

CPAM Annual Workshop

3/12/2026

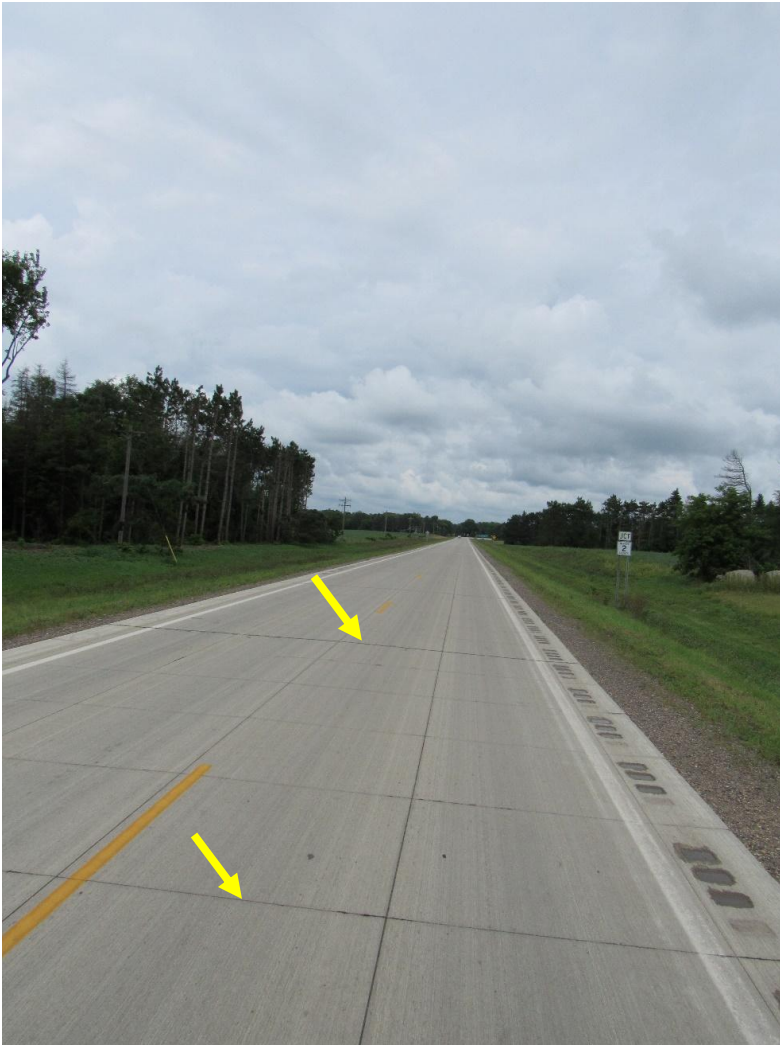
Non-Uniform Joint Deployment in COAs

- Higher and inconsistent levels of faulting
- Increased potential for buckled panels
- Bumps from sealant in dominant joints

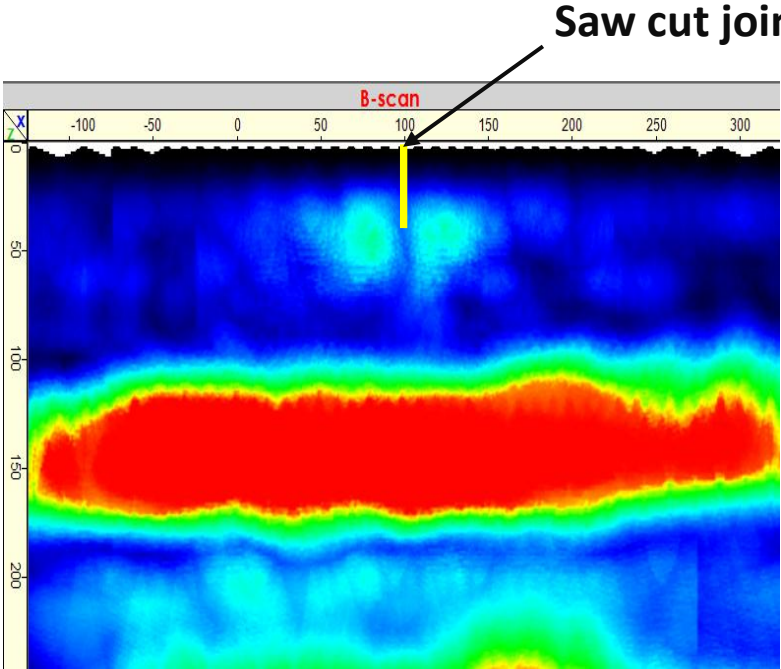
Joint not deployed

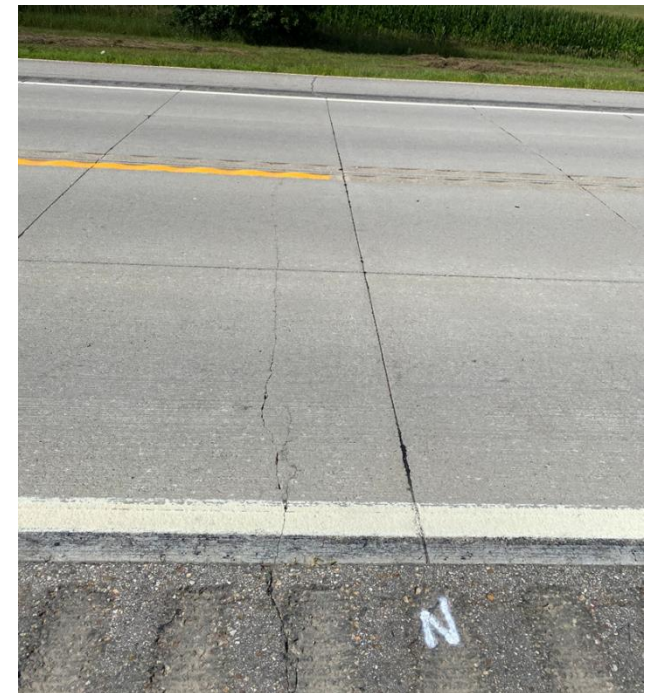
**Crack near undeformed joint
(aligning with major reflective crack)**

- First round of early loading 24 hours after paving resulted in 4% deployed joints (checked shortly after loading)
- Second round of early loading 17 hours after paving resulted in 10% deployed joints (checked shortly after loading)

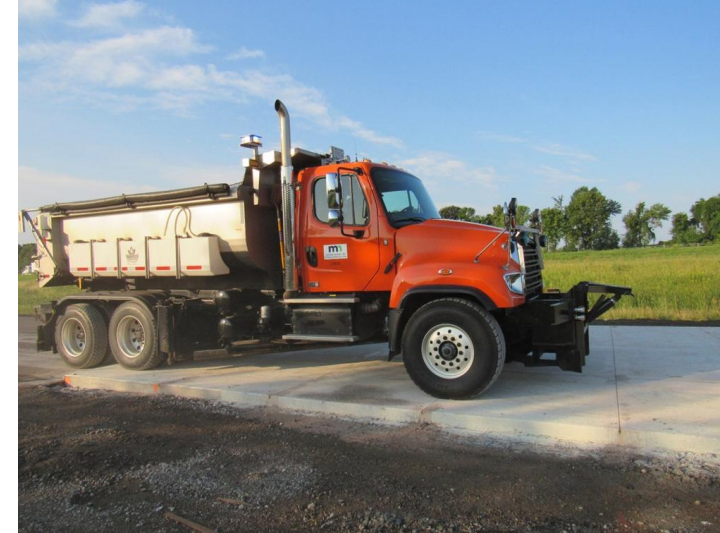
- 52,000-pound tandem axle dump truck
- 22 hours after paving
 - 5 slow (5 mph) passes on driving/passing lane of test section 2227 only
- 28 hours after paving
 - 5 slow (5 mph) passes were made on driving lane of both test sections
 - 5 fast (30 mph) passes were made on passing lane of both test sections

Cell 2227	Cell 2226	
Passing Lane	←			30 mph
	→		28 hour loading	
Driving lane	←	22 hour loading		5 mph
	→		28 hour loading

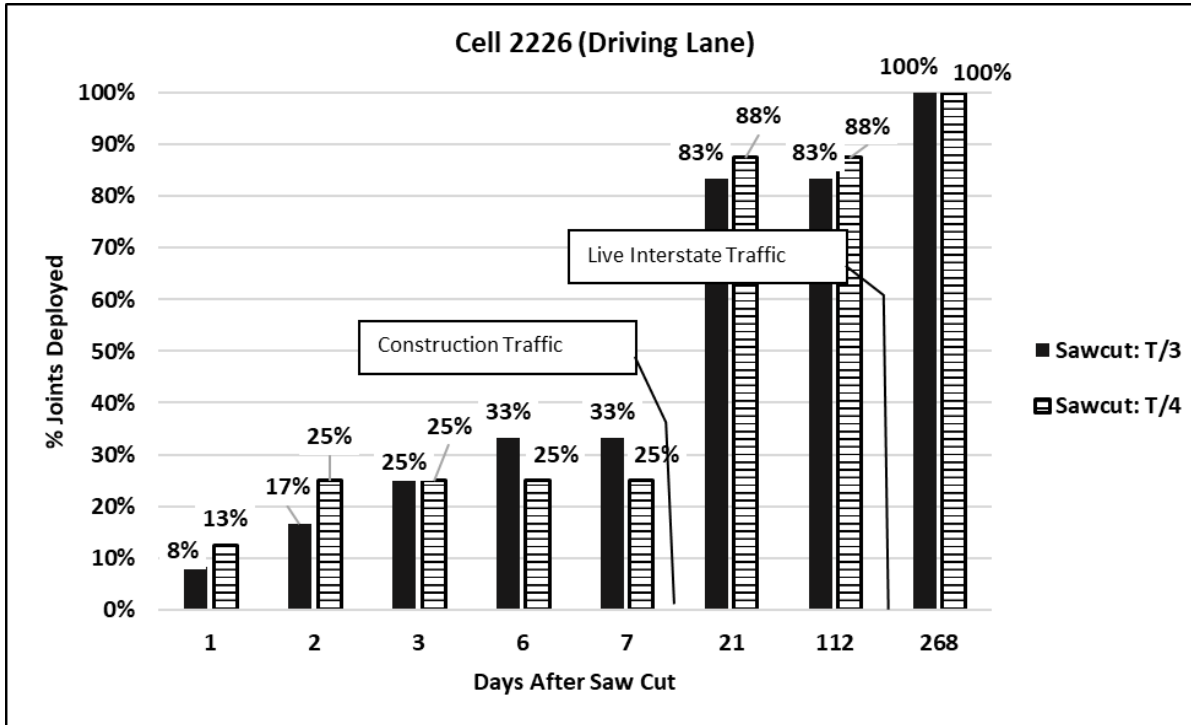
Loading @ 28 hours, 5 mph

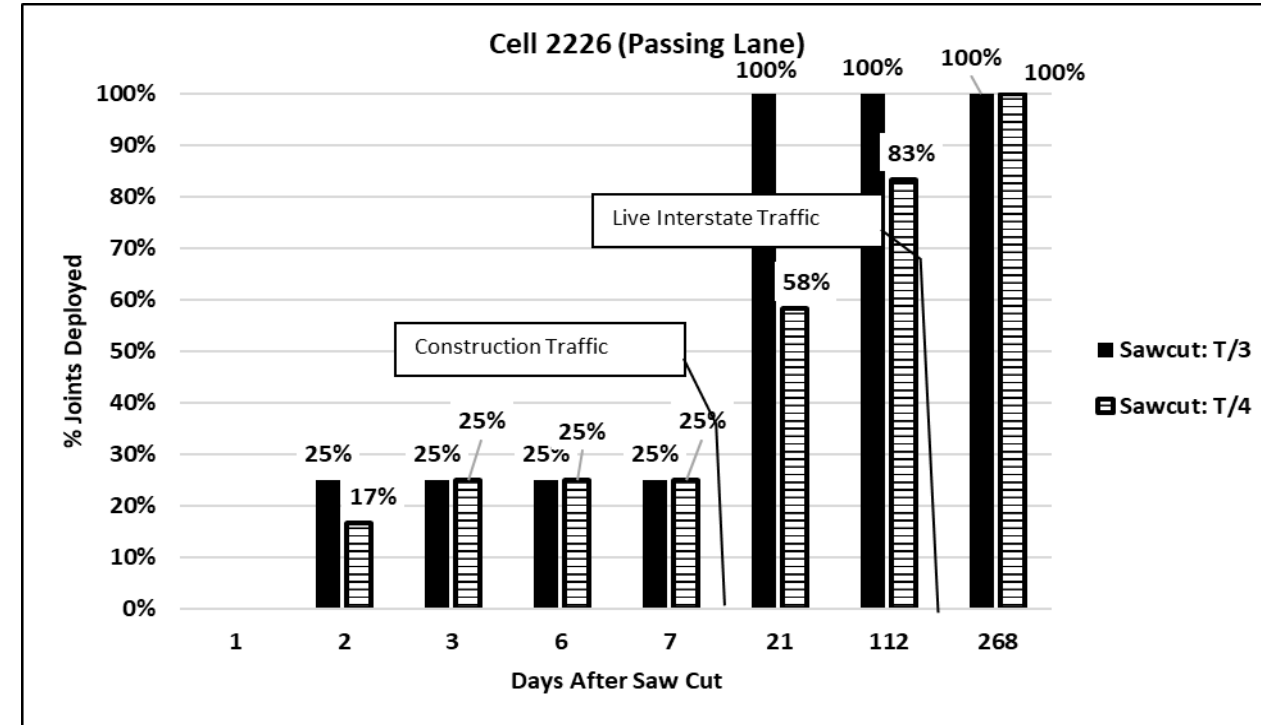
Loading @ 28 hours, 30 mph
